DNARD Rev. 5.0 Video Rework 15 June 1998

This notice is for the Digital Network Computer Reference Design, Revision 5. It provides rework instructions for the video controller circuit to minimize certain image instability problems that can be observed on the monitor. The rework involves removing one resistor and relocating three discrete components (that are already on the board) so that these problems are eliminated.

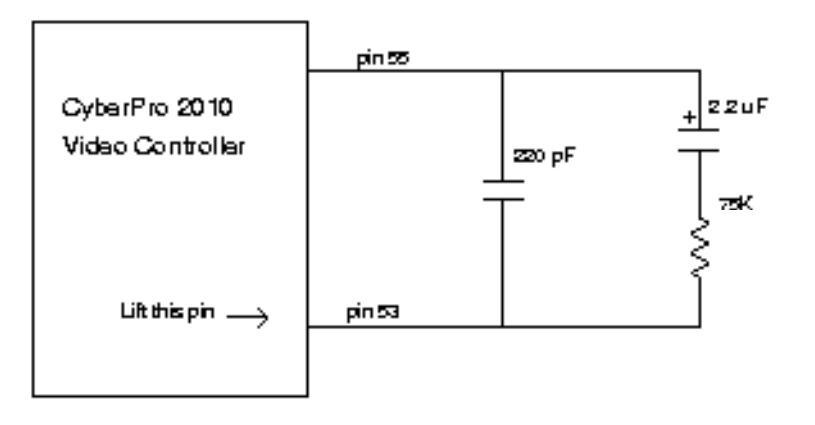
Schematic: (Click on schematic for full-size version in Adobe PDF format)

This rework eliminates two different forms of video instability. One involves "swimming" of the entire image, especially when other I/O is going on. The second involves a more localized "tearing" of one or more sections of the image, which typically happens only when the unit has not fully warmed up.

The rework involves removing one resistor and adding three discrete components.
